**St. Peter & St. Paul's church,
KNAPTON, Norfolk**

Report on eight medieval coffin lids with a proposed methodology for their relocation

March 2016

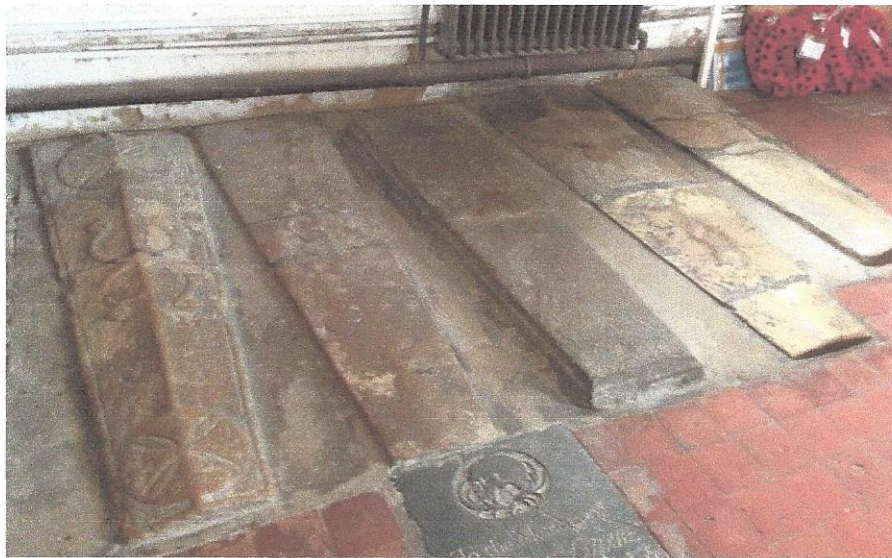
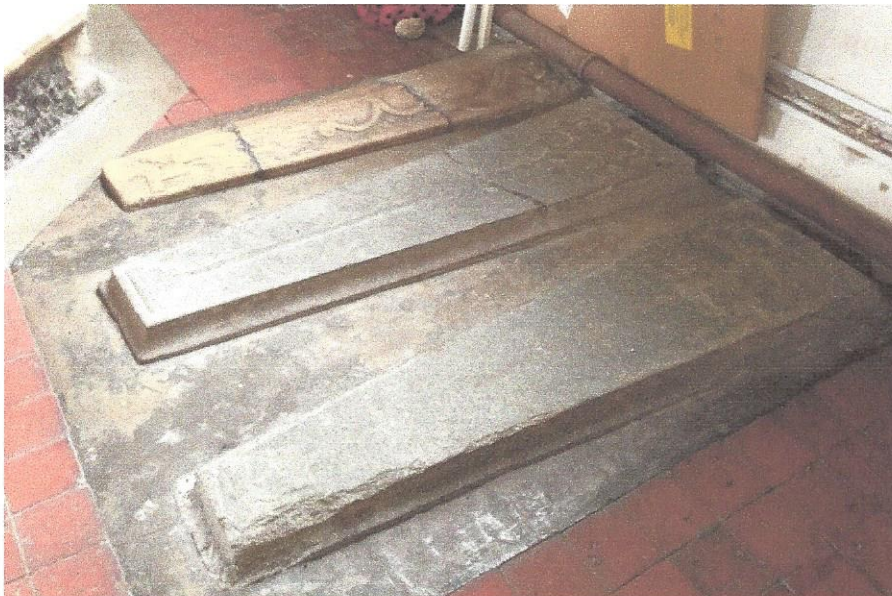
The coffin lids are currently at the west end of the nave, shown in general view in plates 1 & 2 on the front page of this report. They are numbered 1 to 8 working south to north, as shown in the detail of the architect's drawing ref. 01, below.

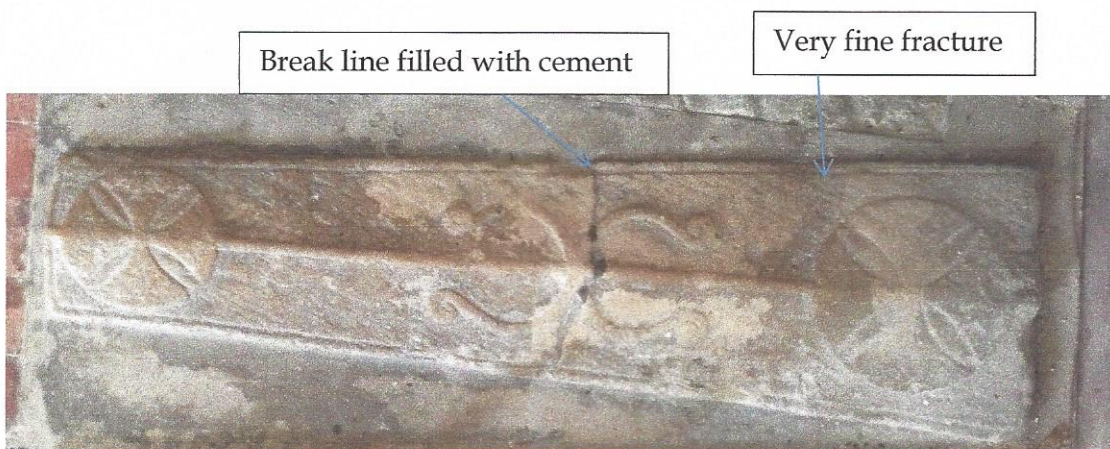
2.1 Coffin lid no. 1

This Barnack³ limestone coffin lid is circa 1980mm long and tapers from 575mm wide at the west to 320mm at the east. It is coped, and has a maximum of about 50mm protruding above the surrounding cement screed.

It appears to have been in two pieces when set in its present position, the break filled with hard cement. There is also a hairline fracture running right the way through, just below the head cross, which looks like a clean break which will come apart when it is moved, but there is no sign of cement fill.

There is a small area of loss to the bottom right-hand corner in the photograph above.

The surface is worn in places, which seems to clearly correlate to the doors of the adjacent cupboard, and is thus almost certainly from foot traffic. Elsewhere the surface of this hard limestone is in remarkably good condition with tool marks still visible.

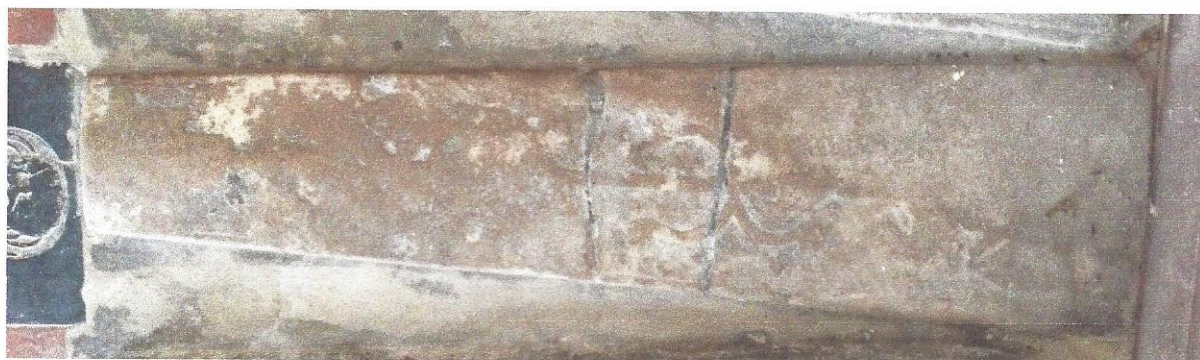
2.2 Coffin lid no. 2

This Barnack limestone coffin lid is circa 2080mm long and tapers from 560mm wide at the west to 285mm at the east. It is only slightly coped, and has a maximum of about 30mm protruding above the surrounding cement screed.

It was in three pieces when set in its present position, the wide breaks crudely filled with hard cement.

The surface is very worn such that much of the original surface tooling and ornamentation is worn away, but this appears to be historic wear with only small areas of 'fresh' stone suggesting that there hasn't been much wear in recent times. The implication is that it was previously outside or in an area of high foot traffic.

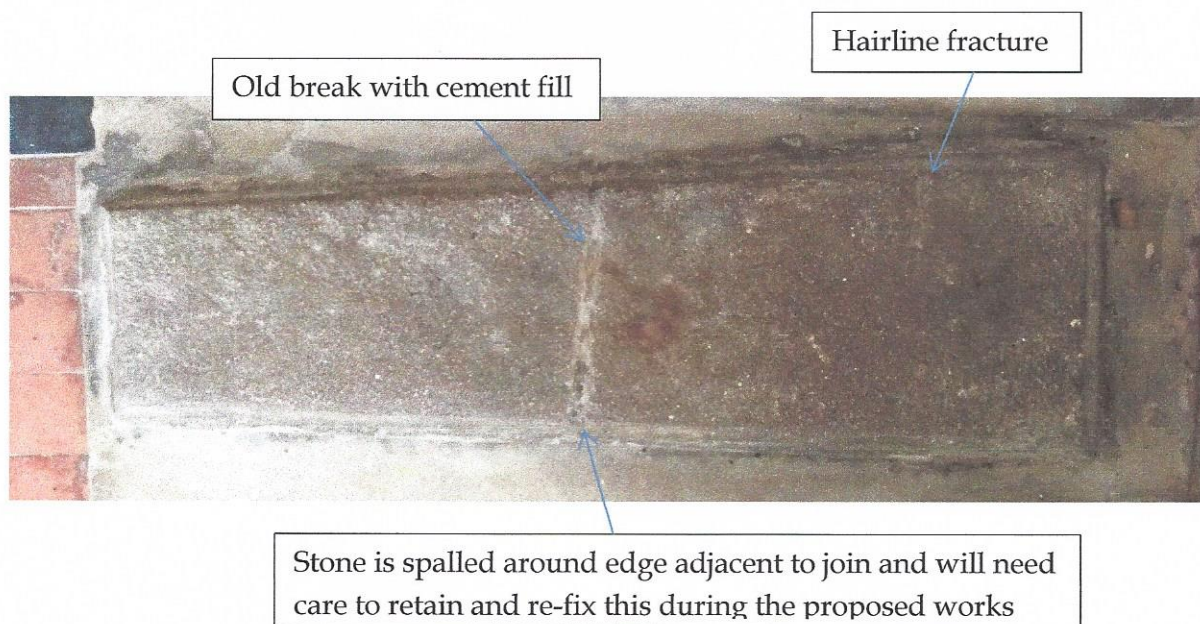
2.3 Coffin lid no. 3

This Purbeck marble⁴ coffin lid is circa 1885mm long and tapers from 595mm wide at the west to 435mm at the east. It is flat-topped, and has a maximum of about 75mm protruding above the surrounding cement screed.

The upper surface is weathered and it cannot be discounted that there was originally some form of surface decoration. There is a double hollow chamfer running around the edge, which is chipped and worn.

Various facets of the condition of the coffin lid are shown on the photograph above. Note the vulnerability of the moulded edge to further damage all the way around, but especially where the spall is indicated. There is also, as shown, a latent fissure. Care will need to be taken not to place pressure on this when the coffin lid is handled.

1. Make a record of the coffin lids including sketches as required to allow reconstruction and photographs.
2. Coffin lids 3 and 8 both have vulnerable edges which should be pre-consolidated using a combination of dispersed lime injection mortar and suitably coloured lime mortar repair fillets. Should disaggregating stonework require consolidating in order to allow fillets to be installed this might be achieved using nanolime (Calosil E25) or by using 5-10% Paraloid B72 acrylic resin in a 50/50 acetone/IMS solvent mix, all subject to site trials. Further repairs of a similar nature may be required to these areas when the slabs are lifted and re-positioned.

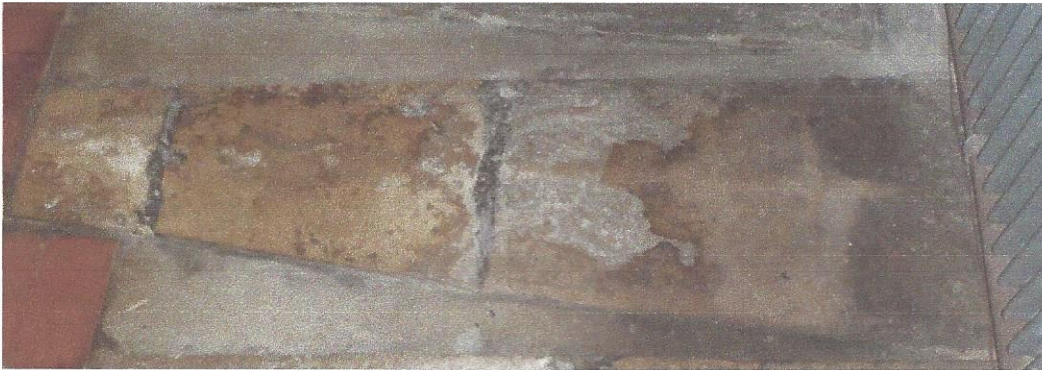
2.4 Coffin lid no. 4

This Barnack limestone coffin lid is circa 2110mm long and tapers from 690mm wide at the west to 335mm at the east. It is only slightly coped, and has a maximum of about 30mm protruding above the surrounding cement screed.

It was in three pieces when set in its present position, the wide breaks crudely filled with hard cement. The breaks are wider at the surface than lower down suggesting that it was very worn when in pieces prior to being placed in its present position.

The surface is very worn such that much of the original surface tooling and ornamentation is worn away, but this appears to be historic wear with only small areas of ‘fresh’ stone suggesting that there hasn’t been much wear in recent times. The implication is that it was previously outside or in an area of high foot traffic.

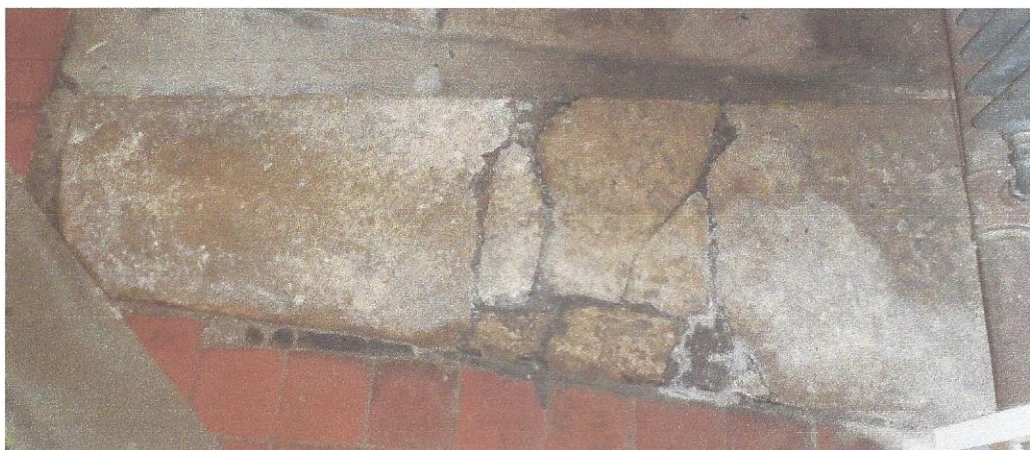
2.5 Coffin lid no. 5

This Barnack limestone coffin lid is incomplete, with an old break at the foot end indicating that it has been truncated. It was further cut to accommodate the font base. What remains is circa 1780mm long and tapers from 615mm wide at the west to 380mm at the east. It is coped, and has a maximum of about 55mm protruding above the surrounding cement screed.

When set in its present position there were two large sections and a somewhat broken up middle section. It has been set together in a hard grey cement. Whereas for the other coffin lids which have been repaired it is possible – or likely – that the cement break fills are relatively superficial it must be assumed that the centre portion to this slab has cement to its full depth, holding the five or more smaller fragments together.

12. A further note is required on the repair of the central part of coffin lid 5. We don't know at this stage how the five or more fragments forming it are going to separate. It may be that this part is best left bound together by cement, and the cement discretely toned in with a lime sheltercoat. Alternatively the pieces may separate quite easily and need to be built back up into a coherent section ready for reinstatement. Re-building might require pins (316 grade threaded stainless steel bar set in polyester resin) and extensive lime mortar reconstruction.

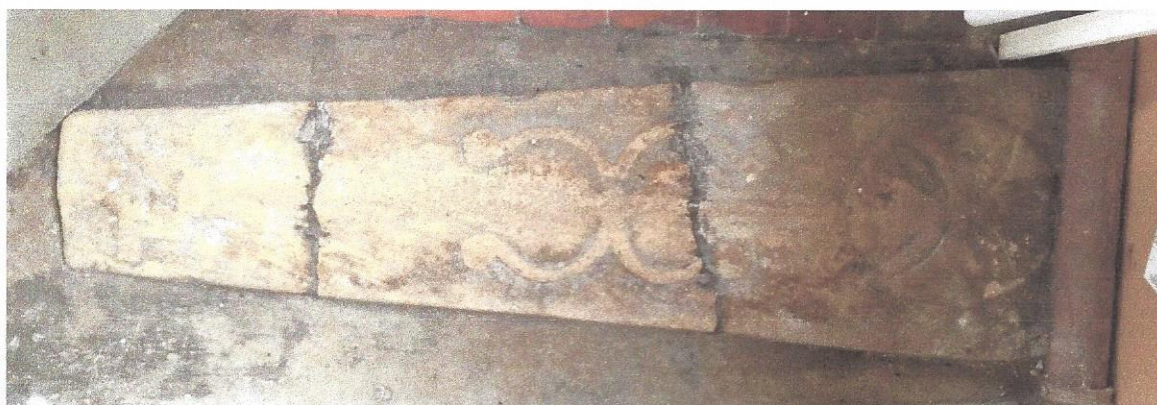
2.6 Coffin lid no. 6

This Barnack limestone coffin lid is circa 1730mm long and tapers from 510mm wide at the west to 260mm at the east. It is coped, and has a maximum of about 85mm protruding above the surrounding cement screed.

It was in three pieces when set in its present position, the breaks filled with hard cement.

The surface has recent wear in places, at the east end which is almost certainly from foot traffic, and chips at the west end probably from having furniture stored on top of it. Elsewhere the surface has more historic wear such that although the ornamentation is still visible no tool marks remain.

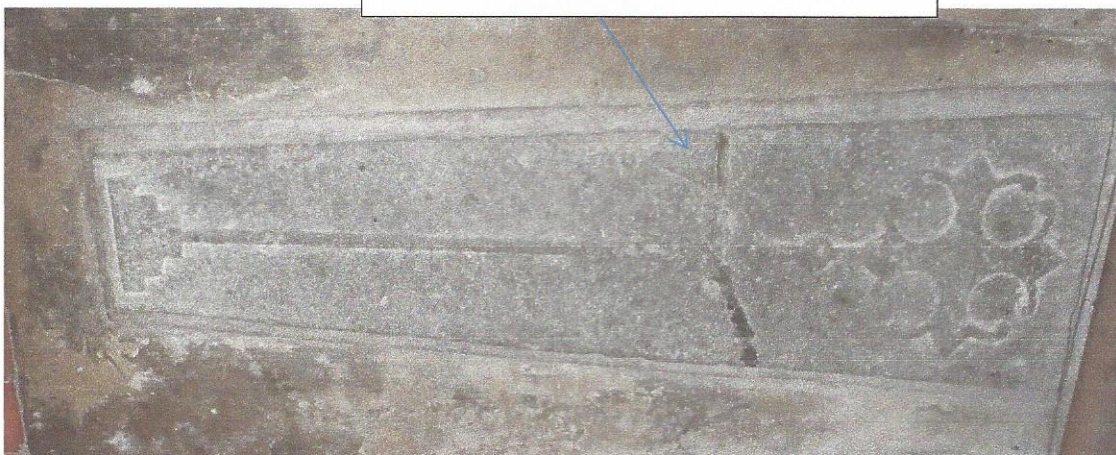
2.7 Coffin lid no. 7

Smaller and neater repair to spalled stone. See text below.

This Purbeck marble coffin lid is circa 1810mm long and tapers from 605mm wide at the west to 345mm at the east. It is flat-topped, and has a maximum of about 80mm protruding above the surrounding cement screed.

There is a single hollow chamfer running around the edge, which is in remarkably good condition.

It has a clean break which has been filled with a hard, grey cement. As shown on the photograph above there is a small and more subtle previous repair adjacent to the more obvious break repair.

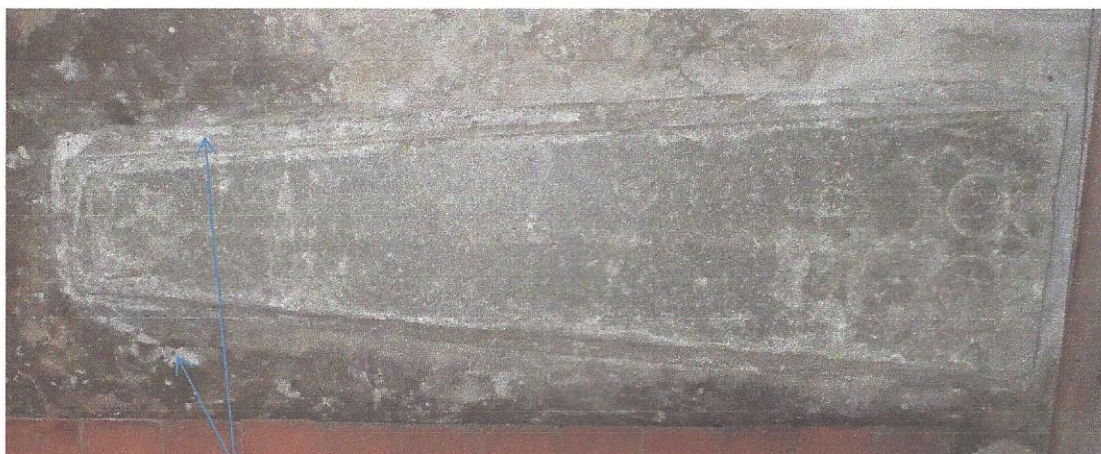
2.8 Coffin lid no. 8

Note soluble salt efflorescence to surrounding cement screed as well as to the edges in particular of the coffin lid.

This Purbeck marble coffin lid is circa 1850mm long and tapers from 605mm wide at the west to 310mm at the east. It is flat-topped, and has a maximum of about 70mm protruding above the surrounding cement screed.

It is complete, with no historic breaks apparent, but unfortunately is in poor condition. There is much wear to the top and the edge moulding appears to be actively deteriorating with evidence of soluble salts being responsible at least in part for on-going deterioration.

16. Tone back any mortar fills as required using a wash of water-based paint on the fill.
17. Note that coffin lid 8 has been affected by soluble salt efflorescence. The salts also affect the surrounding cement screed and are assumed to originate from the ground and to be mobilised by liquid moisture movement. Re-locating the lid will remove it from the source of the salts but will leave some residual in the stone. It is not deemed viable to attempt to remove them by poulticing.

There does remain a danger however that as the lid dries out in the year or so after relocation that there could be further surface damage from salt crystallisation. It is recommended that a conservator re-visit this coffin lid (when the others might as well also be checked) 12 months after the relocation.

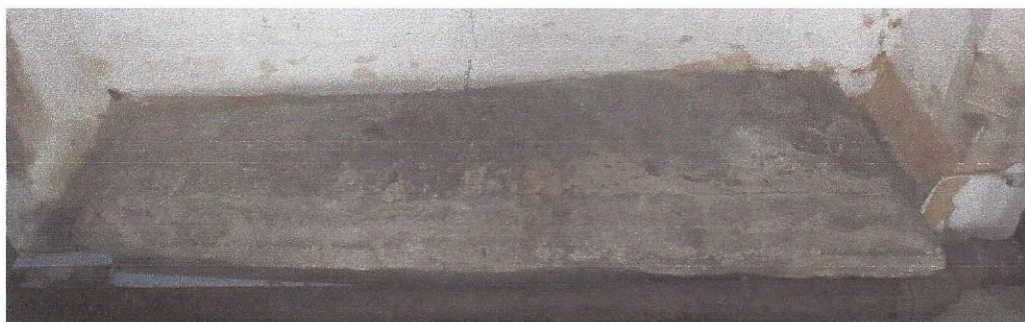
2.9 Coffin lid in south wall recess

The Purbeck marble coffin lid is circa 1830mm long and tapers from c.705mm wide at the west to 390mm at the east. It is flat-topped, and is about 150mm thick.

There is a double hollow chamfer running around the edge.

It is partly buried in the wall.

The decoration comprises a distinctive form of cross head (see 3.1.2 for further details), but the remainder of the surface is weathered – with active on-going deterioration – so the form of shaft and base is not known.
